HYDRAULIC MODEL STUDIES OF NIMBUS DAM SPILLWAY
FOLSOM UNIT--AMERICAN RIVER DIVISION
CENTRAL VALLEY PROJECT, CALIFORNIA

Hydraulic Laboratory Report No. Hyd-431

Subject: Hydraulic model studies of Nimbus Dam spillway--Folsom Unit--
American River Division--Central Valley Project, California

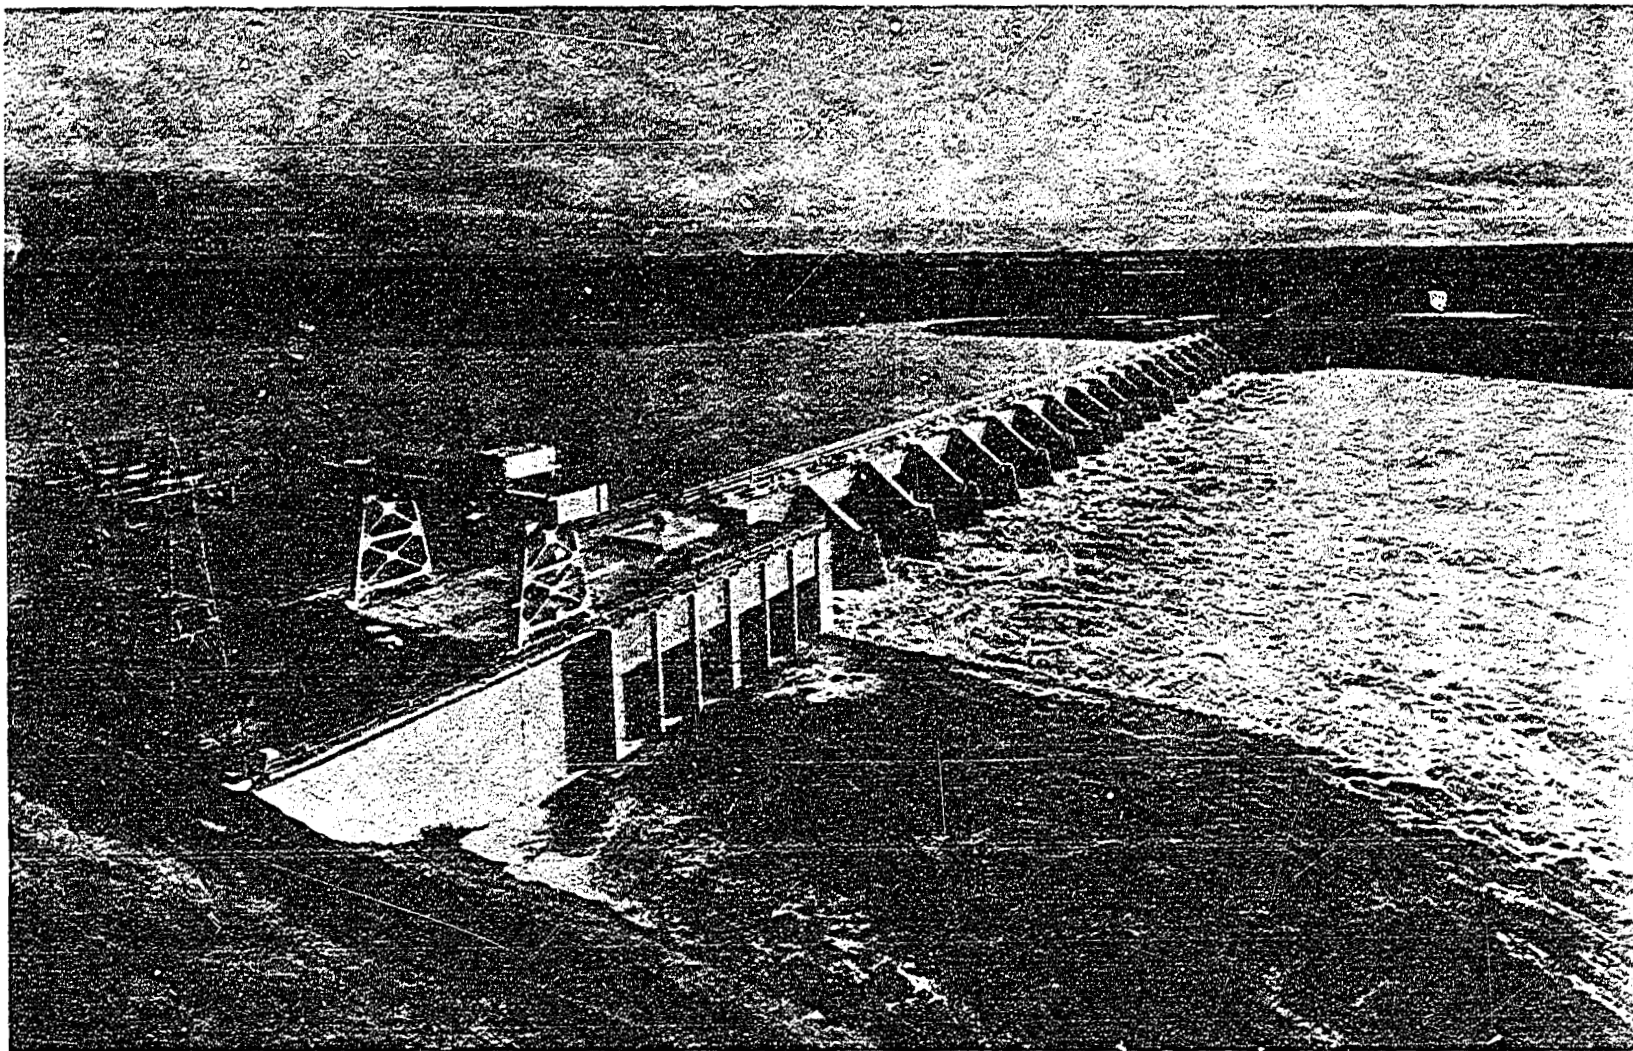
FRONTISPIECE

AR-3058-CV NIMBUS Power plant and dam viewed from downstream right abutment. Total flow is approximately 70,000 c.f.s.

The frontispiece shows the prototype stilling basin performance for 70,000 cfs. Figure 12C shows that the tail-water elevation for 70,000 cfs is about 99.0 feet. The top of the dividing wall between the powerhouse tailrace and the stilling basin is at elevation 100.0, Figure 2. The water surface elevation in the picture is slightly below the top of the wall indicating that the design tail-water curve is correct.

From the appearance of the flow in the photograph, the stilling basin operation is very satisfactory.

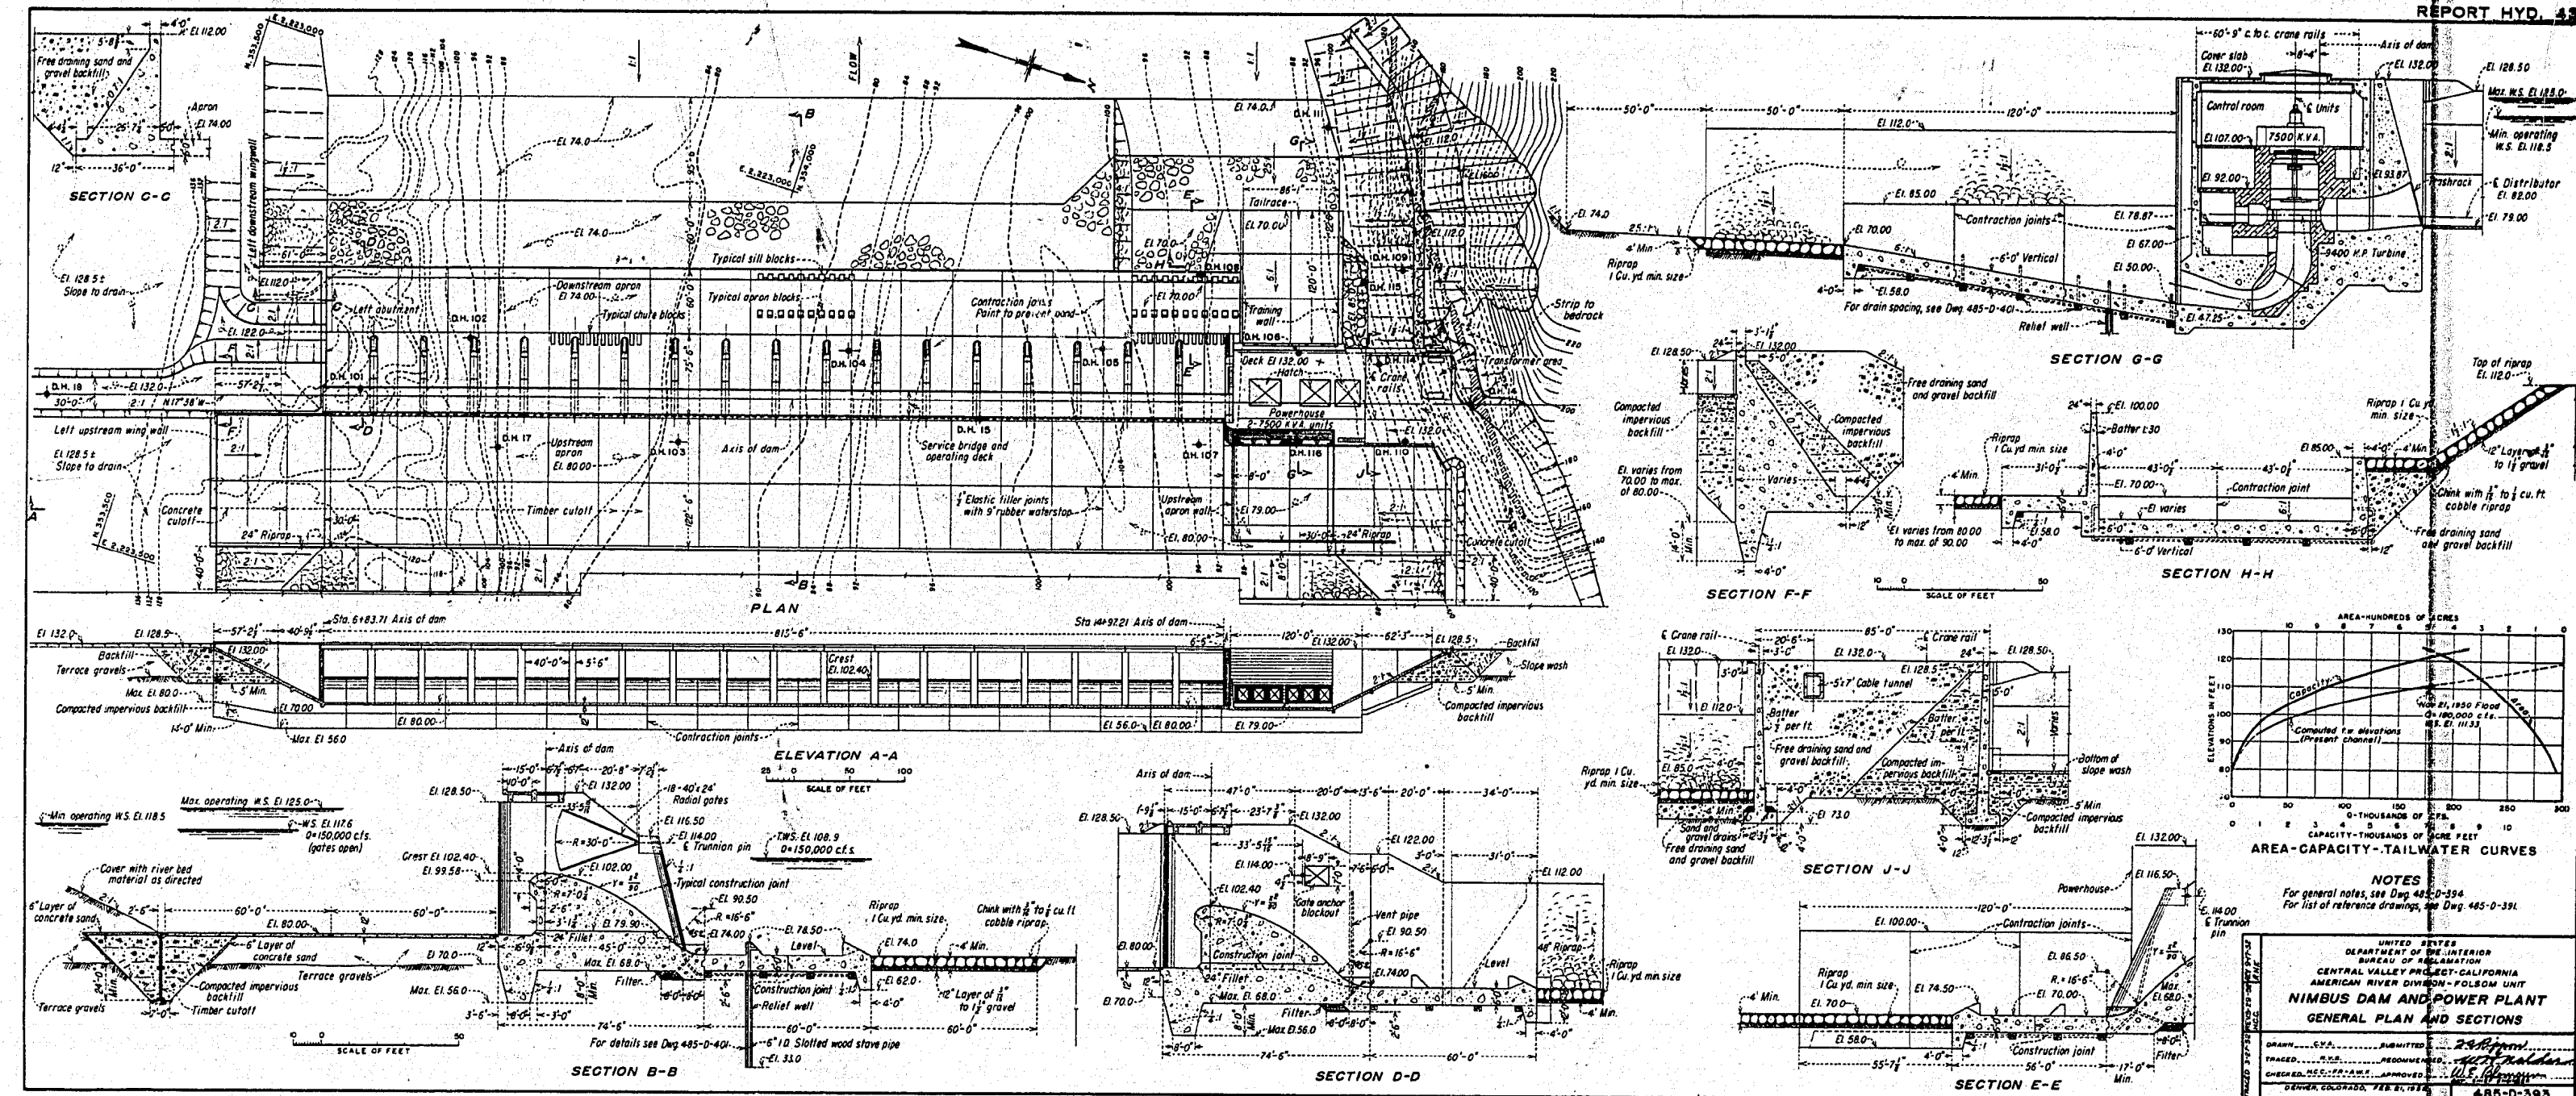
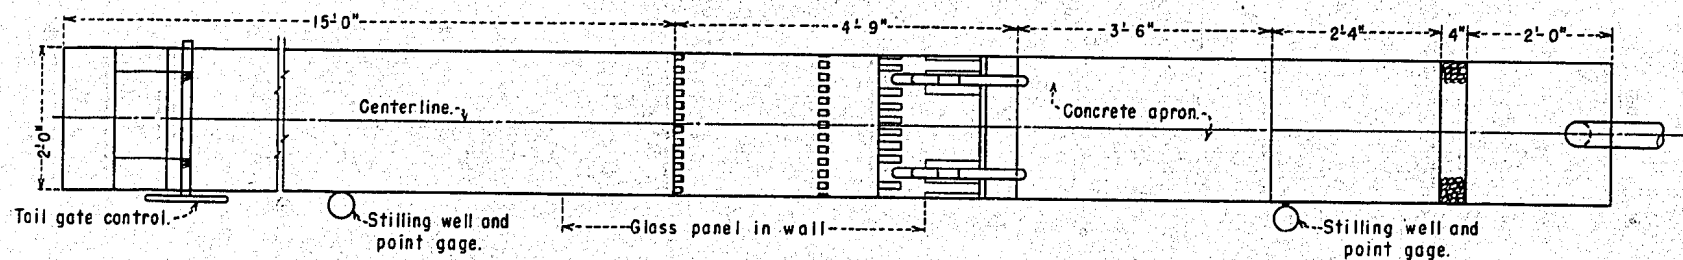
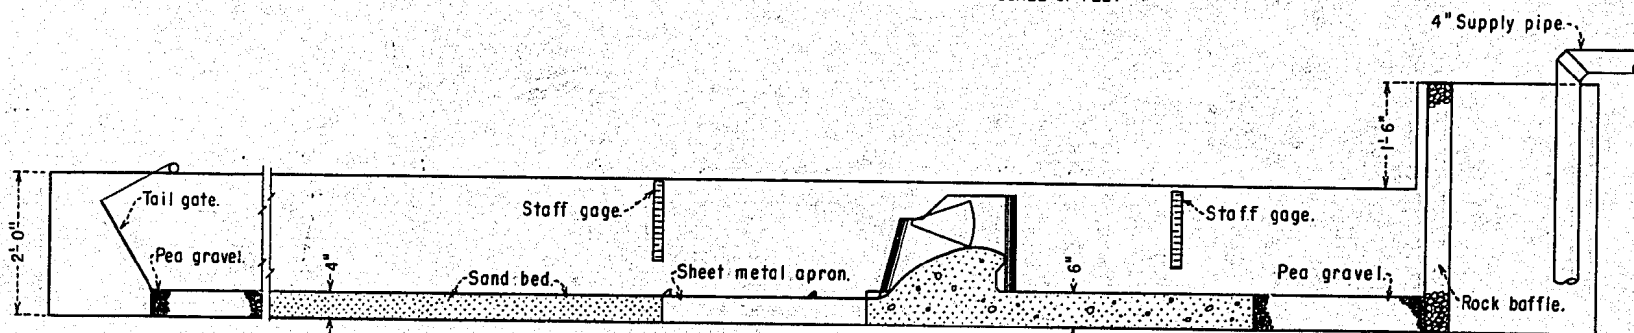
NIMBUS DAM SPILLWAY
HYDRAULIC MODEL STUDIES
1:36 SCALE SECTIONAL MODEL
MODEL DETAILS

PLAN

1. For stilling basin details see Figure 4.
2. For crest details see Figure 15.
3. Preliminary basin shown on this drawing.

SECTION ALONG CENTERLINE

The hydraulic model of Nimbus Dam spillway was built to a scale of 1:36. The model was placed in a 40-foot-long, 2-foot-wide by 2-foot-deep, sheet-metal-lined wood flume. One full bay and two partial bays were included in the model, Figure 3.

A 5-foot-long glass panel was located in one wall of the flume. The crest section of the spillway was placed at the upstream edge of the glass panel with the stilling basin apron in the center of the panel, permitting observation of the stilling action in the basin. Two hundred feet of the prototype forebay and 400 feet of the downstream channel were also modeled in the flume.

Water was furnished to the model from the main laboratory supply system and measured by either a 4-, 6-, or 8-inch Venturi meter. After entering the flume, the water passed through a 6-inch-thick rock baffle before entering the forebay area thus assuring smooth approach flow. The tail-water elevation was controlled by an adjustable gate placed at the downstream end of the flume. The model layout is shown on Figure 3.

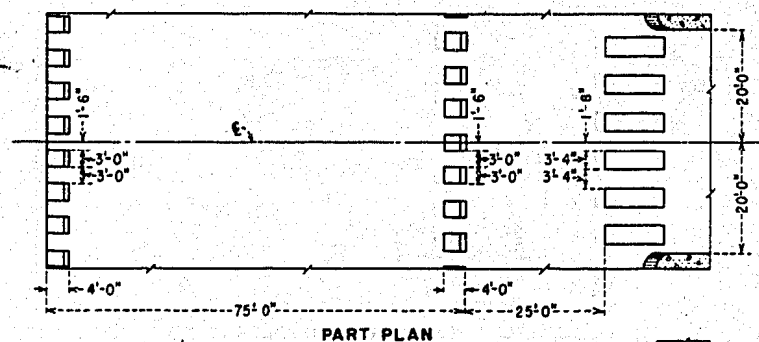
A. PRELIMINARY APRON

PART 7 PLAN

SECTION ALONG E

Preliminary stilling basin. The preliminary stilling basin, Figure 4A, used a horizontal concrete apron 100 feet long. One row of chute blocks and two rows of baffle piers were placed on the apron to improve the stilling action. The chute blocks, located at the toe of the overflow section, were 4 feet high, 3.33 feet wide, and about 16 feet long. The spacing between the blocks was 3.33 feet. The first row of baffle piers was 25 feet downstream from the chute blocks and the second row was located at the end of the apron. The piers were 3 feet wide, 3 feet high, and 4 feet long. The upstream faces of the piers were vertical and the downstream faces had a 1:1 slope. The spaces between adjacent piers were 3 feet; in the downstream row the piers were placed opposite the spaces in the upstream row.

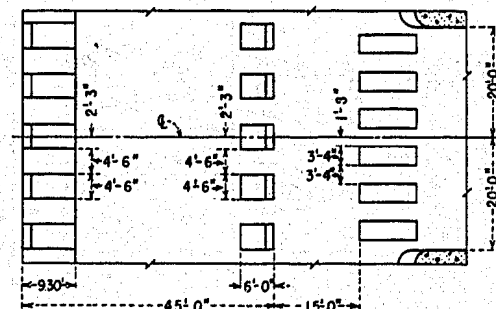
B. FIRST REVISION

PART PLAN

SECTION ALONG C

Stilling Basin Revision No. 1. For the first revision, the basin length was reduced to 60 feet. The preliminary chute blocks were retained but the baffle piers in the first row were made larger and a dentated end sill was used in place of the second row of baffle piers, Figure 4B.

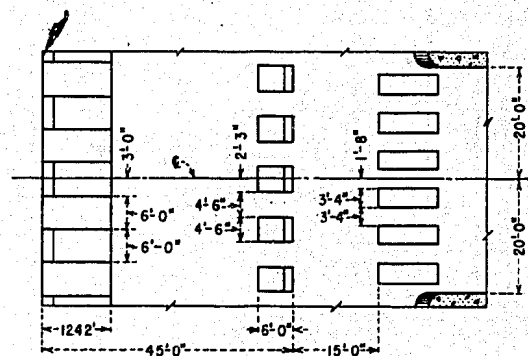
C. SECOND REVISION

PART PLAN

SECTION ALONG C

For this revision the 60-foot-long apron, the chute blocks, and the baffle piers used in the first revision were retained but the dentated end sill was replaced. The length of the sill was increased to 12.42 feet and the height reduced to 3.75 feet. The width of the dentils and the space between the dentils were increased to 6.0 feet, Figure 4C.

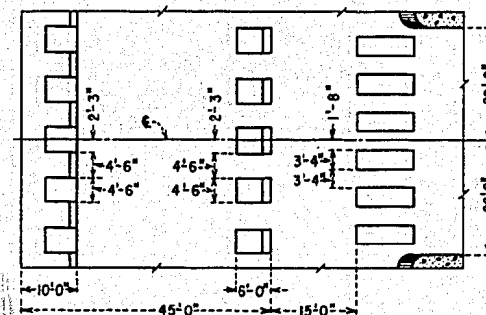
D. RECOMMENDED APRON

PART PLAN

SECTION ALONG C

NIMBUS DAM SPILLWAY
HYDRAULIC MODEL STUDIES
1:36 SCALE SECTIONAL MODEL
STILLING BASIN APRON DESIGNS

Stilling Basin Revision No. 3 Recommended. The recommended basin was 60 feet long and the chute blocks and baffle piers of the previous basin were reused. The end sill, however, was replaced with a dentated triangular sill. The solid portion of the sill was 10 feet long and 2.25 feet high, with 2:1 slopes on the upstream and downstream faces. Dentils, 4.5 feet high and 1.5 feet wide, were placed on the upstream side, Figure 4D.

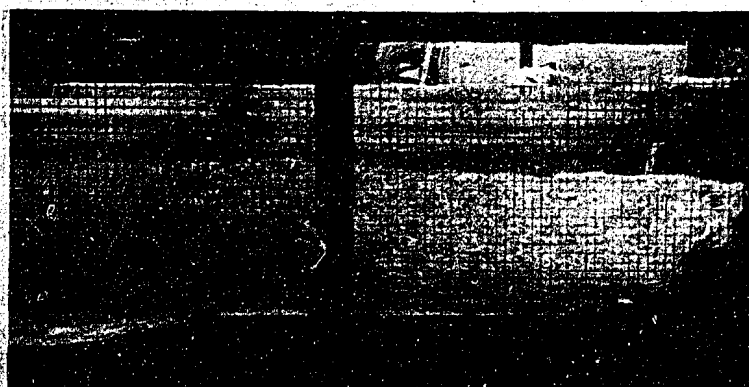
NIMBUS DAM SPILLWAY
Hydraulic Model Studies
1:36 scale sectional model
Preliminary Stilling Basin
Flow Conditions for High Discharges

View from downstream

Side view

Discharge 300,000 second feet through 18
feet through 18 gates. Reservoir elevation
126.7. Tailwater elevation 118.5.

Discharge 150,000 second-feet through 18
gates. Reservoir elevation 125.0. Tail-water
elevation 108.0.

The appearance of the stilling action was very good at all three discharges for the preliminary basin. For 150,000 and 300,000 cfs the stilling action took place on the first 50 feet of the apron, Figure 5. At 50,000 cfs the stilling action extended downstream for about 60 feet on the apron, Figure 6. The maximum wave height averaged about 2 feet in magnitude at the 50,000 and 300,000 cfs discharges; for 150,000 cfs, the waves were negligible. The reduced wave action at the intermediate flow was due to the tail-water depth. At 150,000 cfs the flow after entering the basin was well dispersed with respect to both the length and depth of the basin and the stilling action was complete. At 50,000 cfs the tail-water depth was small resulting in a turbulent hydraulic jump and greater wave action. At 300,000 cfs the tail-water depth was excessive and the flow over the spillway did not penetrate to the full depth and most of the stilling action took place near the surface causing some wave action.

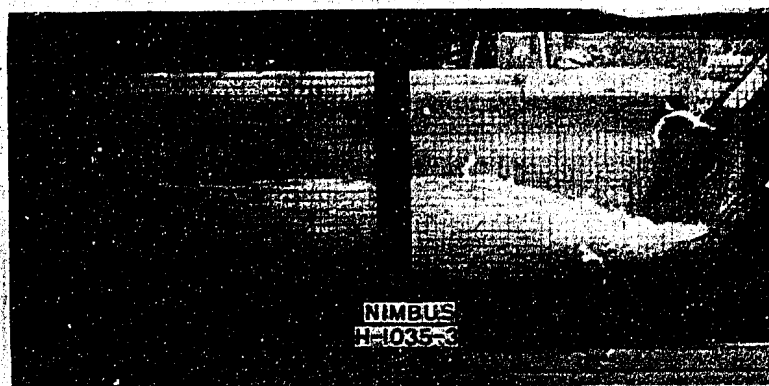
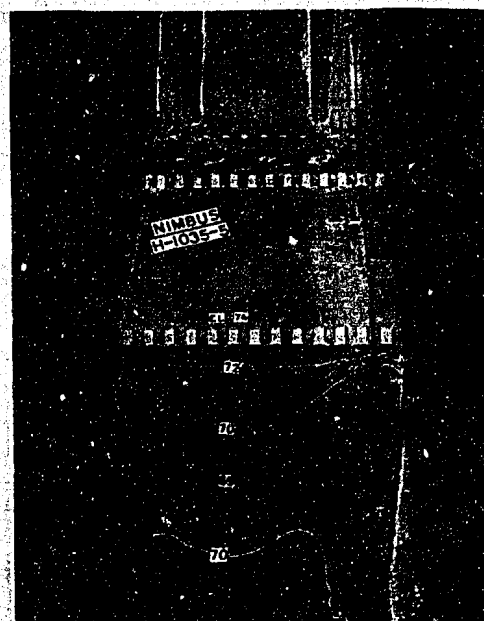
NIMBUS DAM SPILLWAY
Hydraulic Model Studies
1:36 scale sectional model
Recommended Stilling Basin
Flow Conditions for Low Discharge

Side view

Overhead view

Scour after 45 min. operation

Discharge 50,000 second-feet through 4 gates.
Reservoir elevation 125.0. Tail-water elevation 97.0.

The flow appearance was very good with this apron. The stilling action was confined within the limits of the apron for all discharges and the wave heights at the end of the apron were about 1 foot high on the average, Figure 12. For the 50,000 cfs test the maximum depth in the eroded area was about 5 feet, located about 50 feet from the end of the apron, Figure 13. After the 300,000 cfs test, the maximum erosion was only 2.0 feet deep and was 60 feet downstream from the end of the apron.

After the 50,000 cfs discharge, the channel bed at the end of the concrete apron had eroded to a depth of about 6 inches prototype. However, at the larger flow the bed material moved upstream and deposited over the edge of the end sill to a depth of about 2 feet. Tail-water sweepout curves showed that the jump would stay in the basin for all discharges at the normal design tail-water elevations, Figure 7B.

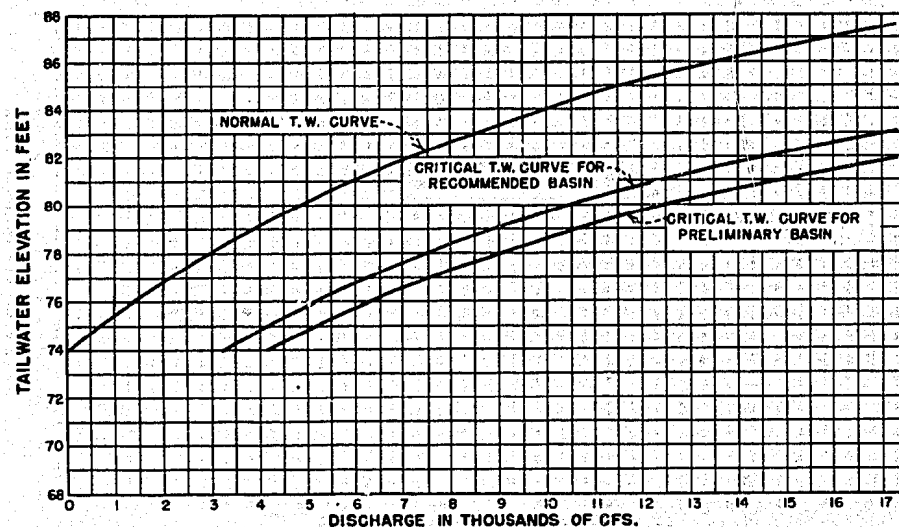
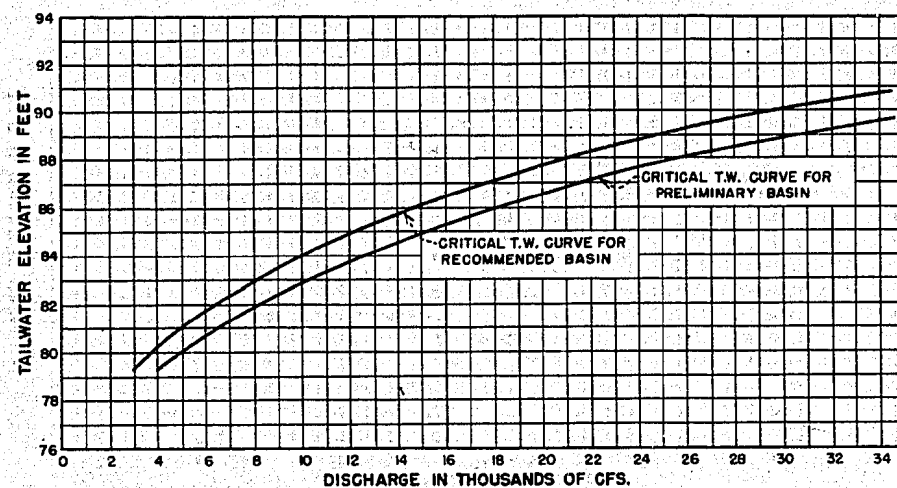
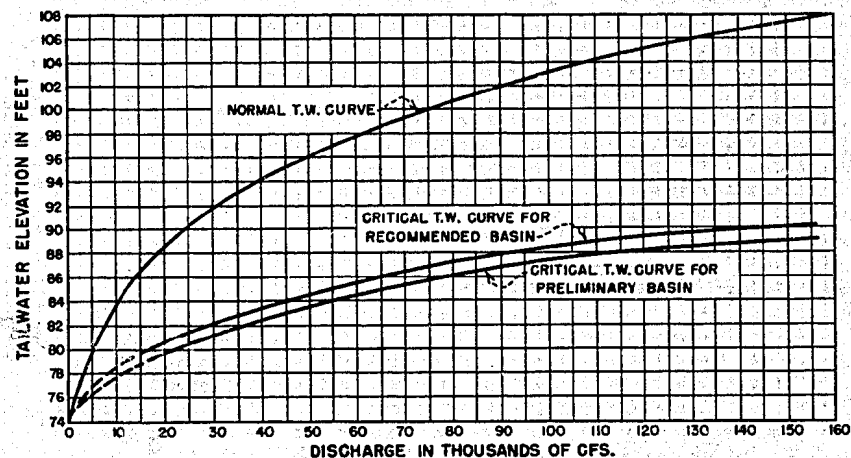
NIMBUS DAM SPILLWAY
HYDRAULIC MODEL STUDIES
1:36 SCALE SECTIONAL MODEL
CRITICAL TAILWATER CURVES FOR
STILLING BASINS

A. TWO POWERHOUSE BAYS OPERATING

B. FOUR SPILLWAY BAYS OPERATING

C. ALL EIGHTEEN BAYS OPERATING

1. Reservoir at elevation 118.5; flow controlled by radial gates.
2. All bays are equally opened.
3. Critical tailwater elevation determined as elevation where hydraulic jump in basin becomes unstable and begins to move downstream on apron.

The amount that the tail-water elevation could be lowered before the stilling action became unsatisfactory was well below the minimum design tail water. Figure 7 shows the tail-water elevation at which the hydraulic jump sweeps out when the 2 sluiceway bays and 4 overflow bays are operating. The normal design tail-water elevation is also shown.

The normal tail-water elevation for 3200 cfs is about 78.0 and the afterbay water level will gradually build up to this elevation. As this buildup takes place the gates in the two bays can be opened to release larger discharges. This should be done in such a way that the tail-water elevation versus discharge relationship always gives a point on or above the critical tail-water curve of Figure 7A. For example, when the tail water reaches elevation 76.0 the discharge through the gates can be increased to as much as 5000 cfs; for elevation 77.0 the release can be about 6200 cfs. The two radial gates can be opened in increments to give these releases until the tail water reaches elevation 79.5 at which time four or more additional gates can be opened. The critical tail-water curve for four gates (excluding the two adjacent to the powerhouse) Figure 7B, shows that a tail-water elevation of 79.5 will permit release of about 3000 cfs through each group of four gates, or 750 cfs per gate. With the tail water at elevation 79.5 it would be permissible to open all spillway gates, in groups of four, to where each gate is discharging 750 cfs. As the tail water builds up each group of four gates can be opened further, in accordance with the critical tail-water curve of Figure 7B.

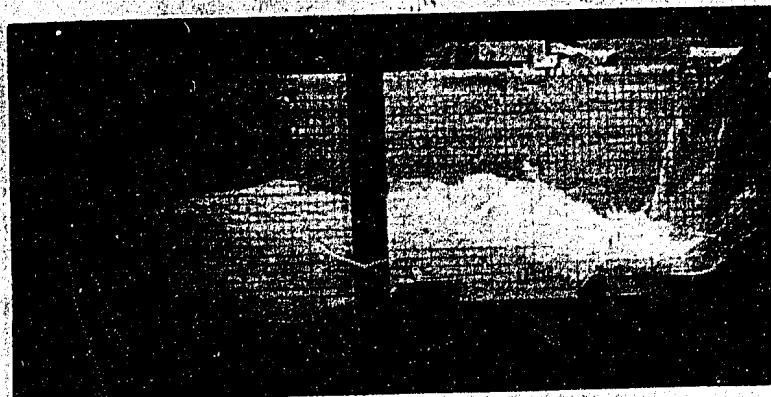
NIMBUS DAM SPILLWAY
Hydraulic Model Studies
1:36 scale sectional model
Stilling Basin Revision No. 1
Flow Conditions for High Discharges

Side view

Over head view

Scour after 45 min. operation

Discharge 50,000 second-feet through 4 gates.
Reservoir elevation 125.0. Tail-water elevation 97.0.

For 50,000 cfs the deepest erosion was 7.0 feet and occurred about 50 feet downstream from the basin. At 300,000 cfs the eroded area was about 100 feet downstream from the basin and was also 7.0 feet deep. At both discharges some of the eroded material moved upstream and was deposited against the end of the apron to a depth of about 2 feet. It was also noticed that the deepest part of the erosion was farther downstream from the end of the apron than it had been for the preliminary design.

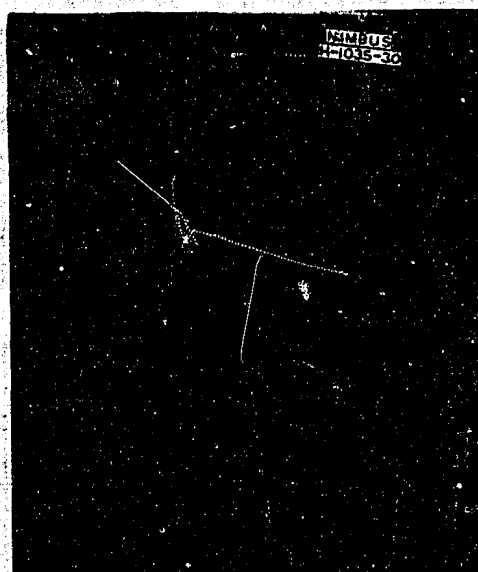
NIMBUS DAM SPILLWAY
Hydraulic Model Studies
1:36 scale sectional model
Stilling Basin Revision No. 2
Flow Conditions for High Discharges

Overhead view

Side view

Discharge 300,000 second-feet through 18 gates. Reservoir elevation 126.7. Tail-water elevation 118.5.

Discharge 150,000 second-feet through 18 gates. Reservoir elevation 125.0. Tail-water elevation 108.0.

The flow appearance for 150,000 and 300,000 cfs was very good, Figure 10. At 50,000 cfs the stilling action took place within the limits of the apron, but was accompanied with considerable surface roughness resulting in waves that averaged about 2 to 3 feet in height at the end of the apron, Figure 11.

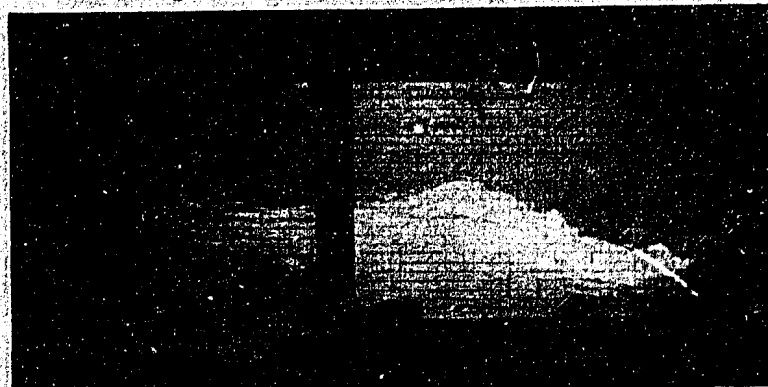
NIMBUS DAM SPILLWAY
Hydraulic Model Studies
1:36 scale sectional model
Stilling Basin Revision No. 2
Flow Condition for Low Discharge

Side view

Overhead view

Scour after 45 min. operation

Discharge 50,000 second feet through 4 gates.
Reservoir elevation 125.0. Tail-water elevation 97.0.

The eroded area for the 50,000 cfs test was about 7 feet deep with the deepest part about 48 feet downstream from the end of the apron, Figure 11. After the 300,000 cfs test the erosion was 7.0 feet deep with the deepest area about 90 feet from the end of the apron. In both tests, some of the bed material moved upstream and was deposited against the end sill to a depth of about 2 feet.

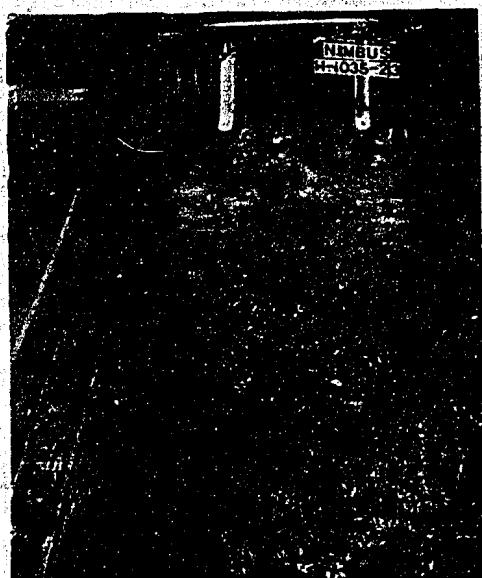
NIMBUS DAM SPILLWAY
Hydraulic Model Studies
1:36 scale sectional model
Recommended Stilling Basin
Flow Conditions for High Discharges

Overhead view

Side view

Discharge 300,000 second-feet through 18 gates. Reservoir elevation 126.7. Tail-water elevation 118.5.

Discharge 150,000 second-feet through 18 gates. Reservoir elevation 125.0.

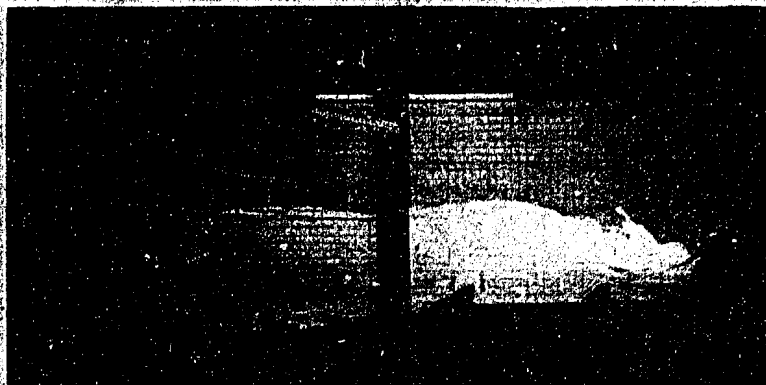
NIMBUS DAM SPILLWAY
Hydraulic Model Studies
1:36 scale sectional model
Preliminary Stilling Basin
Flow Conditions for Low Discharge

Side view

Overhead view

Scour after 45 minutes
operation.

Discharge 50,000 second feet through 4 gates.
Reservoir elevation 125.0. Tail-water elevation
97.0.

Erosion resulting from the 50,000 cfs discharge was moderate, the maximum depth of about 5 feet was located approximately 52 feet downstream from the end of the apron, Figure 6. The channel bottom at the end of the stilling basin remained at the same elevation as the apron floor after this test. There was greater erosion from the 300,000 cfs discharge with the deepest area being 7.5 feet located about 48 feet from the end of the basin. The channel bed at the end of the basin had eroded to a depth of 6 inches below the apron floor.

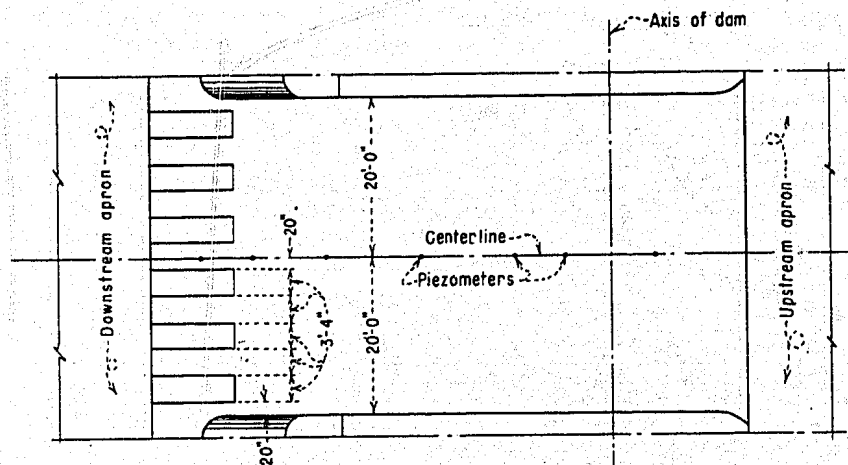
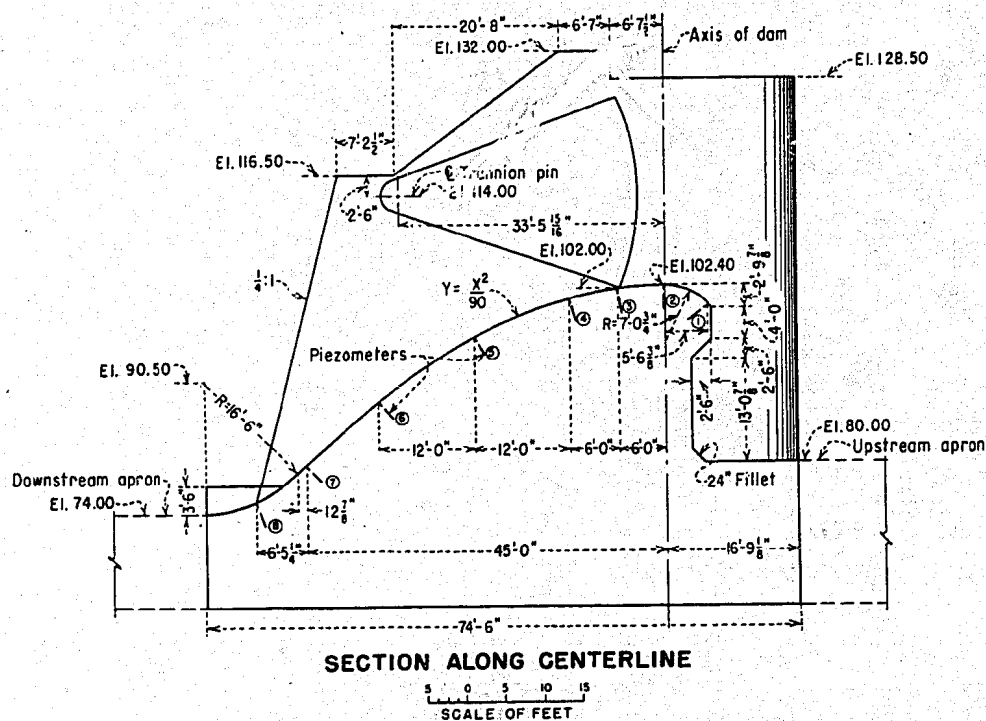
NIMBUS DAM SPILLWAY
HYDRAULIC MODEL STUDIES
1:36 SCALE SECTIONAL MODEL
CREST PROFILE AND PRESSURES

PIEZO- METER NO.	PRESSURE IN FEET OF WATER (PROTOTYPE)							
	RESERVOIR AT ELEVATION 125.0 FEET							
	GATE OPENING							
	1'	3'	5'	7'	9'	11'	13'	15'
1	26.0	24.6	24.5	24.0	22.8	22.3	22.3	20.5
2	23.4	21.0	19.7	18.2	17.0	16.0	16.0	14.7
3	1.0	1.0	1.7	2.8	3.7	4.7	5.7	6.8
4	0.4	0.6	0.8	1.0	1.5	1.8	2.1	3.0
5	0.3	0.2	0.3	0.4	0.7	0.8	1.0	1.6
6	0.0	-0.1	0.0	0.0	0.3	1.0	1.4	2.2
7	0.8	4.4	6.8	10.2	14.2	17.0	19.3	21.3
8*	9.2	10.3	16.5	22.5	29.3	33.2	39.0	38.0
8**	1.5	0.0	-0.7	-3.5	-3.0	-1.0	2.5	5.2

NOTES
* Tailwater at normal elevation.
** Tailwater lowered so that jump was
downstream from chute blocks.

Pressure measurements on the spillway crest section revealed no pressures near the cavitation range. The lowest pressure measured was equivalent to about 4 feet of water below atmospheric, Figure 15.

Pressure measurements. Pressure measurements were made using piezometers placed in the center of the full bay of the spillway model. Readings were made for controlled flow at eight different gate openings and for two free flow conditions all at the maximum reservoir elevation. The results of this test are shown on Figure 15. The pressures were near or above atmospheric for all piezometers except No. 8. This piezometer was located at the toe of the crest; when the tail water was lowered and the hydraulic jump moved downstream the pressure at this piezometer was reduced. The minimum pressure recorded at this piezometer was equivalent to 3.5 feet of water below atmospheric. Since this was well above the cavitation range, no change in the crest profile was recommended. The drop in pressure at Piezometer No. 8 with the low tail water was probably caused by the action of the flow around the chute blocks. The chute blocks deflected part of the flow laterally and the change in direction of the flow lines was reflected in the reduced pressure at the piezometer. With the high, or normal, tail water the jet is submerged and the directional effect of the chute blocks greatly reduced.
